Catastrophic structural collapse
of subfloor timbers

I am writing to inform you of a problem in our villa unit in the Gippsland township of Wonthaggi.

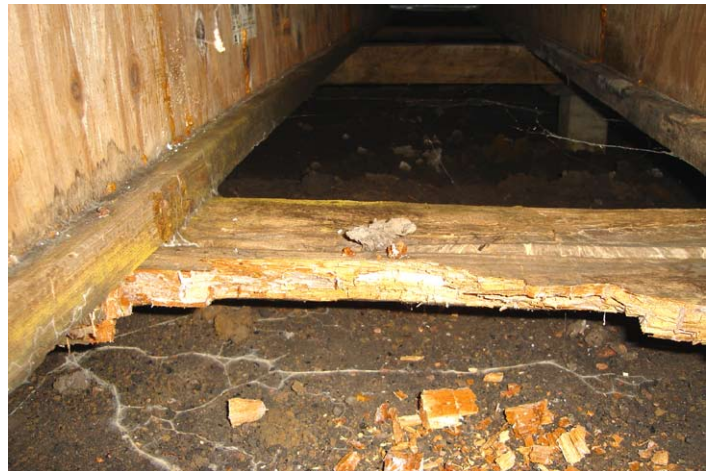
VIEW BETWEEN I-BEAM JOISTS: STYRENE/FOIL REMOVED

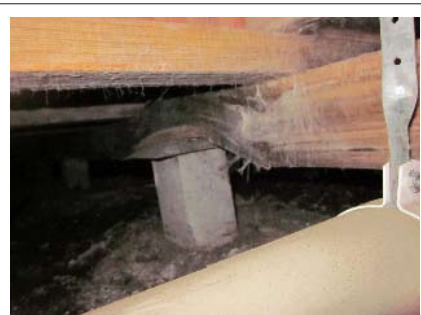
As the insulating foam is sitting on and supported by the subfloor timber (bottom plate of I-BEAM joist), this condensed water then soaks into the wood, with the result that over time, rot, fungal growth and decay of the sub floor timbers has eventuated causing catastrophic structural collapse! The unit is only 6 years, 6 months old!

BEARER ROTTED & SLIPPING

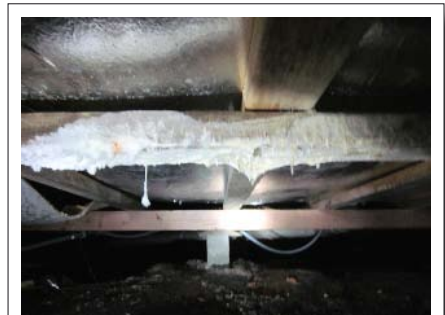
This combination of factors has led to the moisture laden air, which is trapped between the ground and the underside of the foil laminated styrene foam insulating material, to condense as water, on the underside of the insulating foil laminated foam.

STYRENE/FOIL BETWEEN JOISTS
& FUNGAL GROWTH ON BEARER

The builder was forced to comply, in order he was told, to achieve the "5 Star rating". Had your product, Concertina Foil Batts, perforated for sub floor application been utilized, this situation would have been greatly reduced or avoided, importantly, the 5 Star rating could still have been attained.
