Catastrophic structural collapse
of subfloor timbers

I am writing to inform you of a problem in our villa unit in the Gippsland township of Wonthaggi.

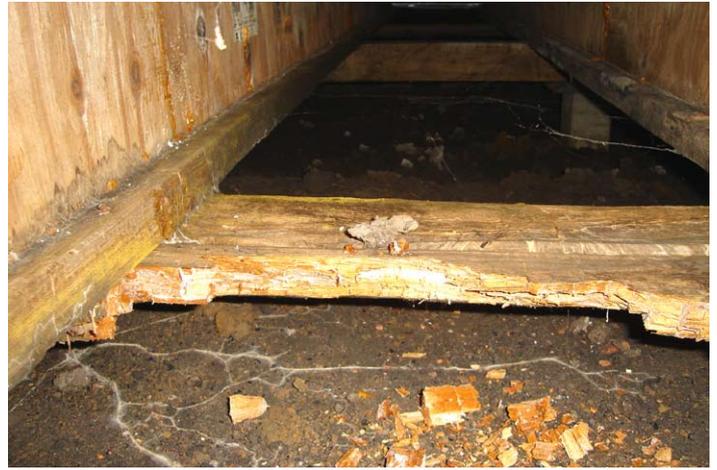
As the insulating foam is sitting on and supported by the subfloor timber (bottom plate of I-BEAM joist), this condensed water then soaks into the wood, with the result that over time, rot, fungal growth and decay of the sub floor timbers has eventuated causing catastrophic structural collapse! The unit is only 6 years, 6 months old!

VIEW BETWEEN I-BEAM JOISTS: STYRENE/FOIL REMOVED

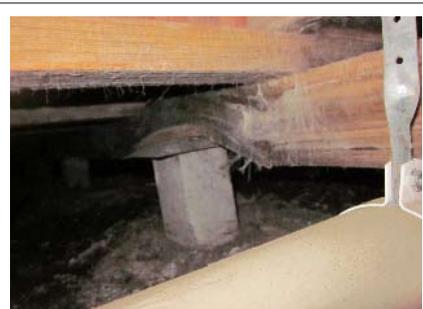
BEARER ROTTED & SLIPPING

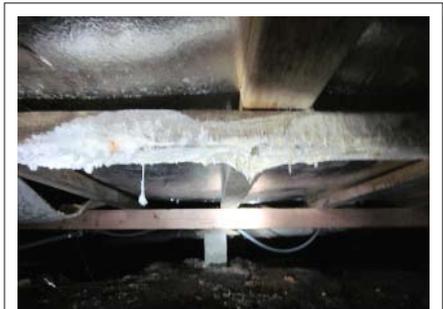
This combination of factors has led to the moisture laden air, which is trapped between the ground and the underside of the foil laminated styrene foam insulating material, to condense as water, on the underside of the insulating foil laminated foam.

STYRENE/FOIL BETWEEN JOISTS
& FUNGAL GROWTH ON BEARER

The builder was forced to comply, in order he was told, to achieve the "5 Star rating". Had your product, Concertina Foil Batts, perforated for sub floor application been utilized, this situation would have been greatly reduced or avoided, importantly, the 5 Star rating could still have been attained.
